WATER and RELATED LAND RESOURCES ESTANCIA SUB-BASIN UPPER RIO GRANDE BASIN NEW MEXICO

PRELIMINARY EARLY ACTION OPPORTUNITIES

**A Report Based on a Cooperative Study by
THE UNITED STATES DEPARTMENT OF AGRICULTURE
and the
NEW MEXICO STATE ENGINEER**

PREPARED BY
SOIL CONSERVATION SERVICE - ECONOMIC RESEARCH SERVICE - FOREST SERVICE
ALBUQUERQUE, NEW MEXICO 1971

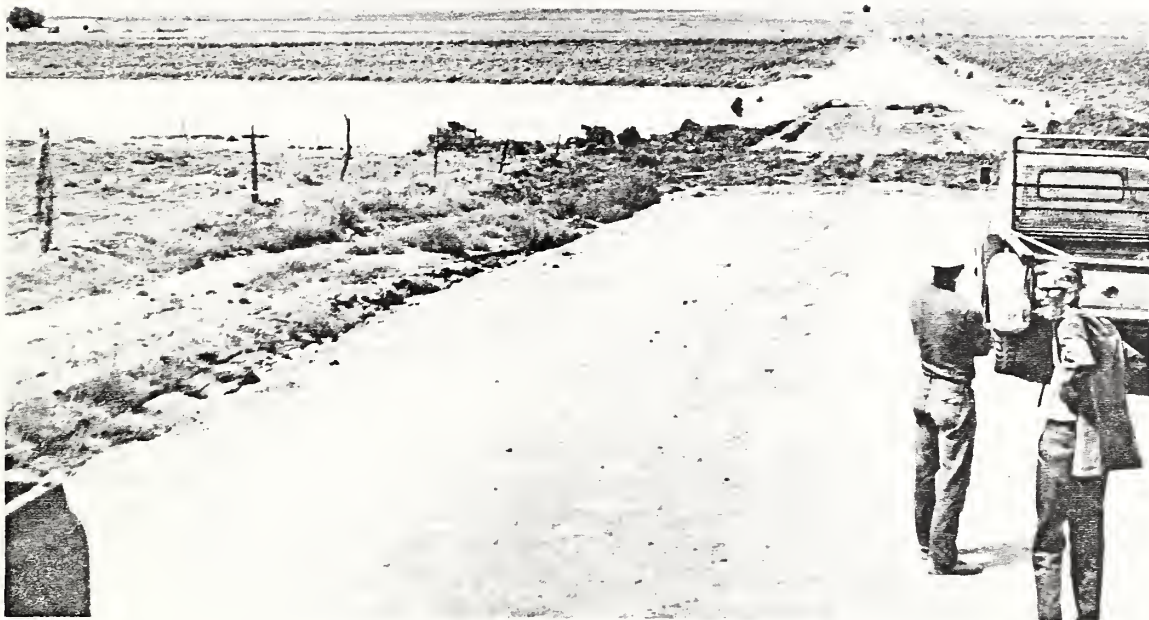
SCS PHOTO 12-P573-5

Highway and crop damage from floodwater from Tajique and Torreon Draws.

Watershed problems identified in the investigation are (1) flood damage to irrigated farms, state, county, and private roads, and the railroad; (2) loss of flood runoff to natural lakes or basins which prevent beneficial use of the floodwater, and (3) erosion and sediment damage from poorly vegetated areas in the upper watershed.

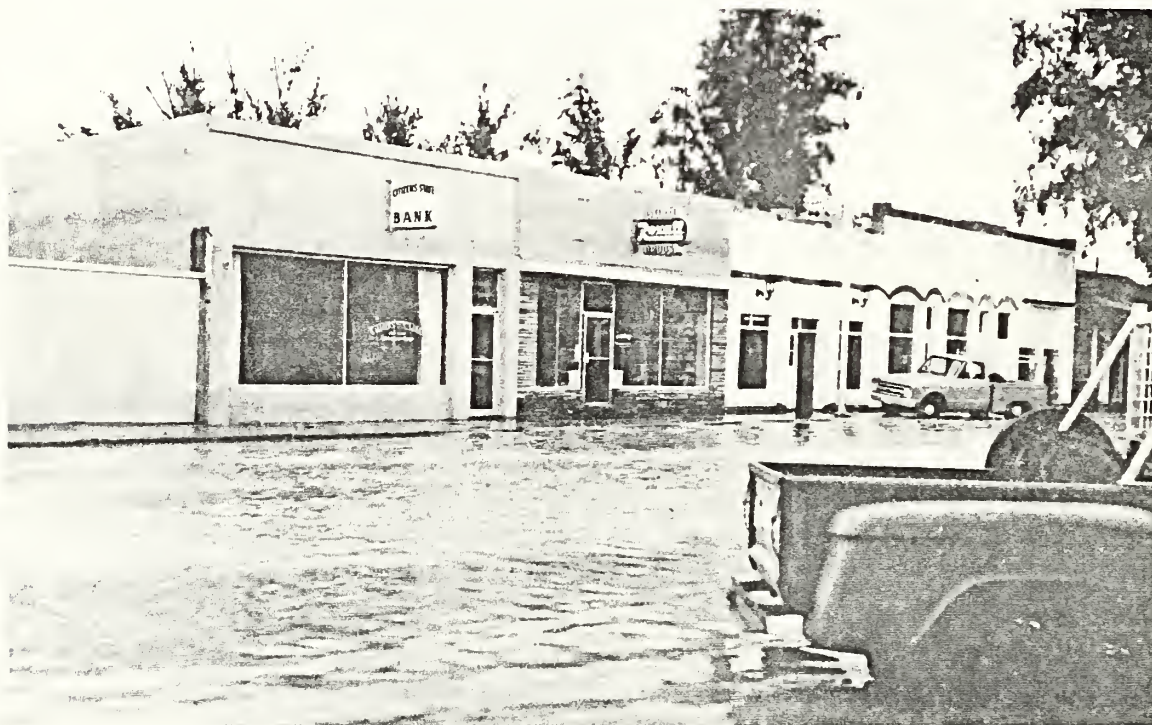
SCS PHOTO 12-PS14-7

Main street of Estancia, New Mexico under floodwaters from Milbourne and Compton Draws

The principal watershed problems are flood damage to irrigated land and associated improvements, urban damage in Estancia, and damage to highways, roads, and the railroad. Other significant problems are erosion by wind and water to unprotected upland areas of the watershed particularly the formerly cropped fields.

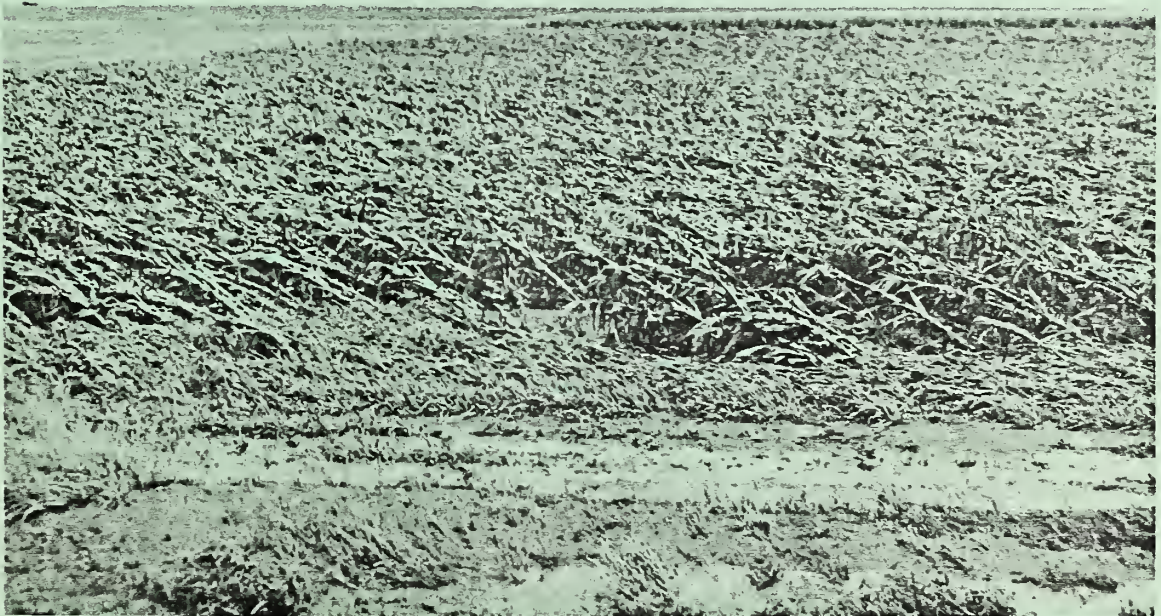
SCS PHOTO 12-P573-3

Typical floods in Estancia Subbasin. Corn damaged by floods.

damage includes farm irrigation systems consisting of wells, pumps, and distribution systems; farm improvements; farm roads, and farm equipment. Damage to crops and pastures consists of actual loss, deterioration in quality and the added expenses of harvesting and cleaning up of debris.

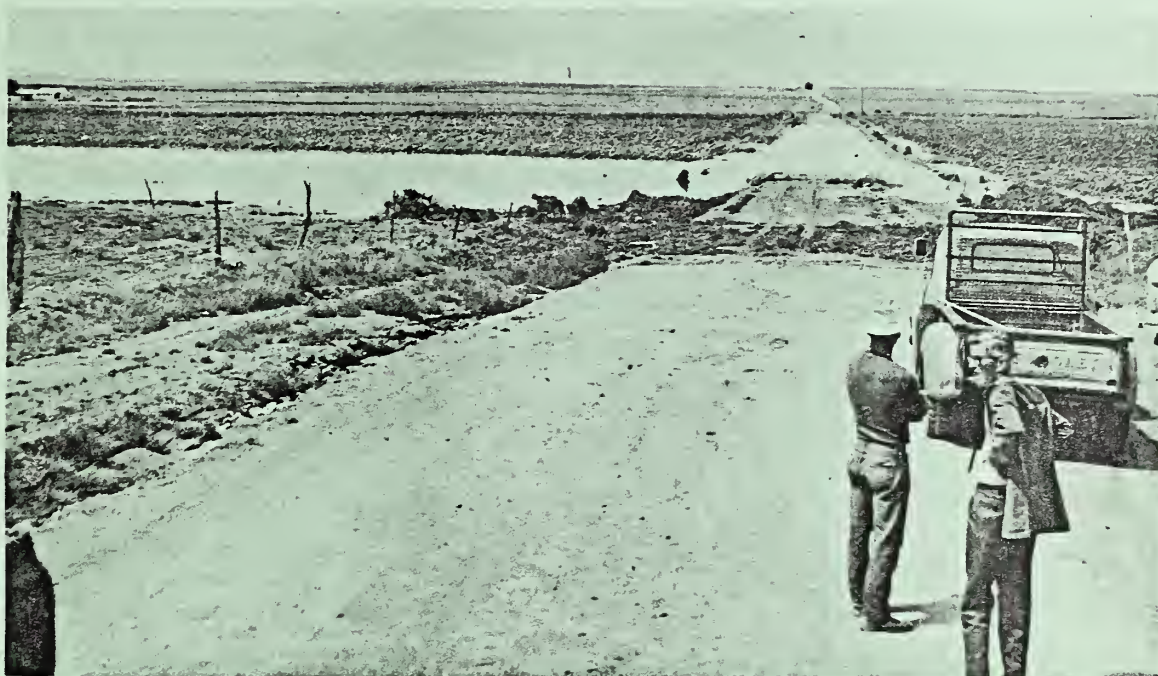
SCS PHOTO 12-P573-5

Flood damage to roads and crops

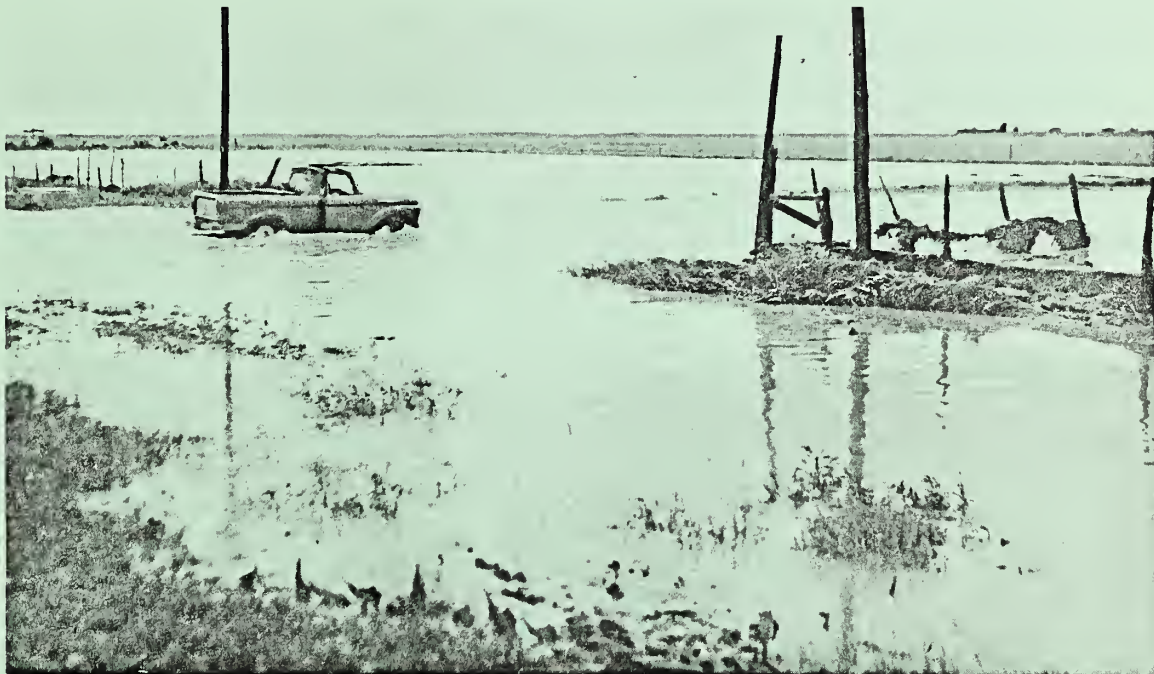
SCS PHOTO 12-PS14-11

Irrigated land damage. Note high-water mark on fence

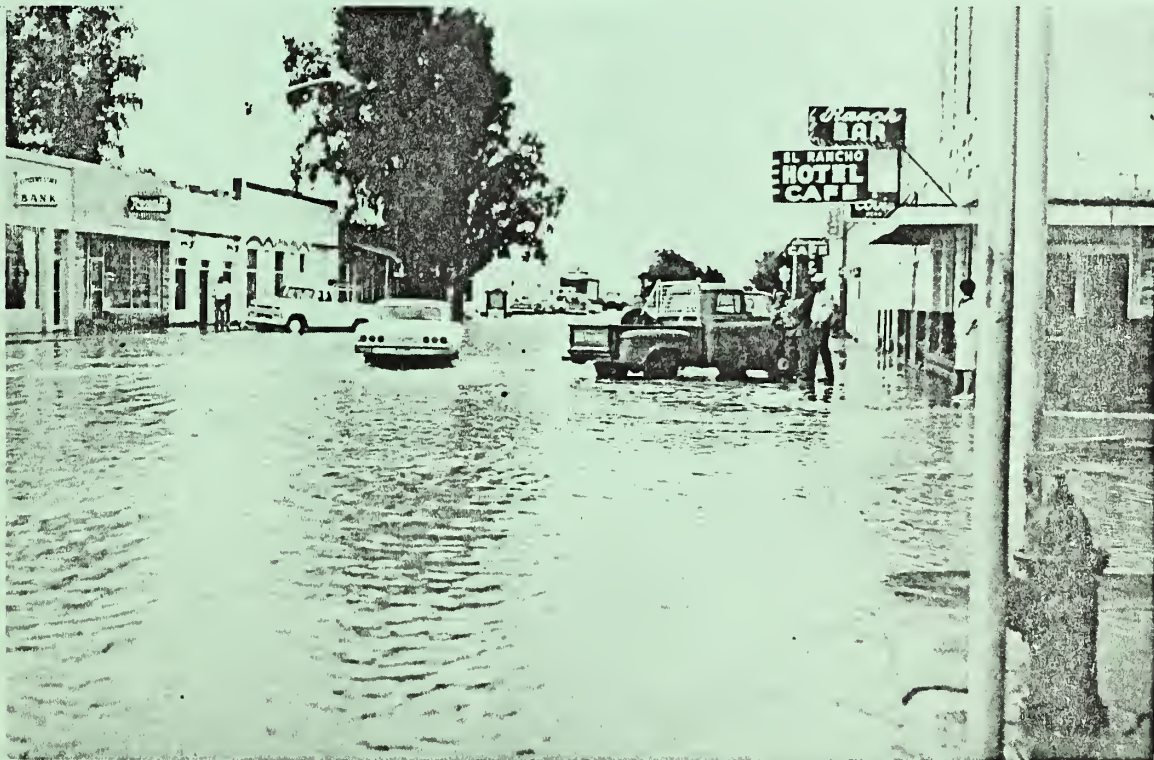
SCS PHOTO 12-PS14-12

Main street of Estancia under floodwater from August 1967 flood from Milbourne and Compton Draws.

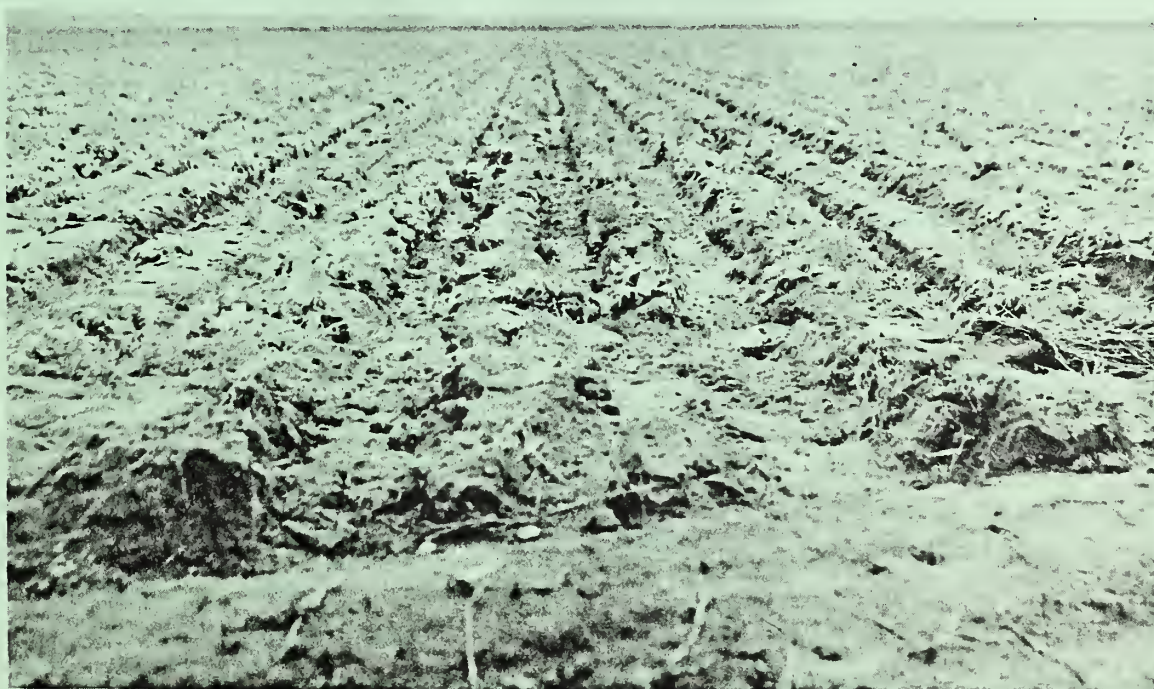
SCS PHOTO 12-P573-8

Lettuce crop destroyed by floodwater from 1967 storm. Irrigated crops are damaged frequently by floods.
